# Case Study

SOLVING CLOGGING FROM  
SEEDS & SKINS

## TOMATO PROCESSING TANK WASHING SOLUTION

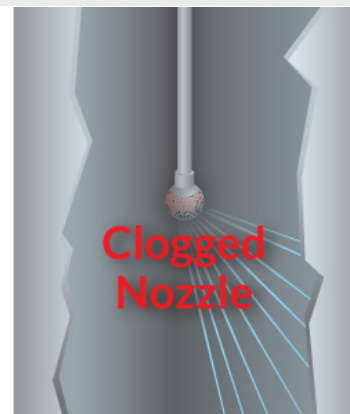
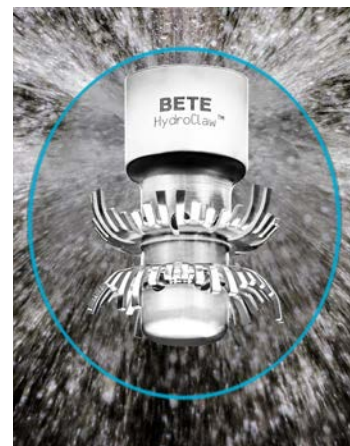
After assessing the dimensions of their vessels, BETE engineers recommended six HydroClaw® 100 nozzles, three for each tank. The ¼" free passage makes them an ideal solution for flushing through tomato seeds and skins with the recirculated water.

The low-maintenance HydroClaw® self-flushes as it cleans tanks without any rotating parts or gears to jam up.

- Nozzle designed to let particulates and sediment flow through with no clogging
- Clog resistance and low maintenance = reduced downtime and more economical water usage
- 316L stainless steel construction means it is perfect for clean-in-place (CIP) and food grade applications
- Complete 360-degree coverage
